Safety Inspection Report

Annual Inspection

Bracklesham Park Playground

21 July 2025

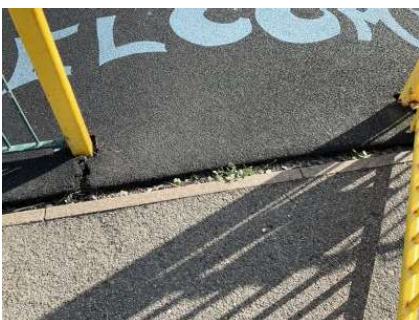
Trip points on the surface.

Wet pour edge lifting at gates.

Repair.

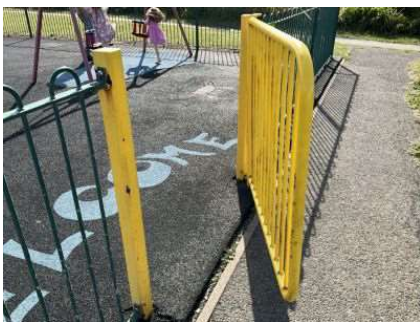
The gate's closing mechanism does not work correctly.

Dogs may gain entry.

Adjust to allow gate to self close. Ideally gate from open should not close in less than 5 seconds.

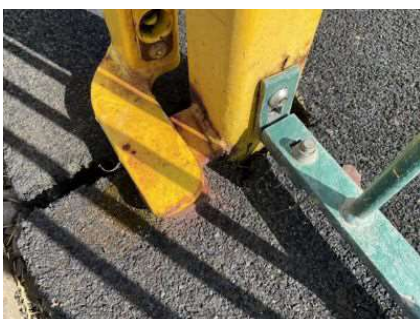
Additional comments are noted below.

Sheering points present.

No reasonably practicable action is identified.

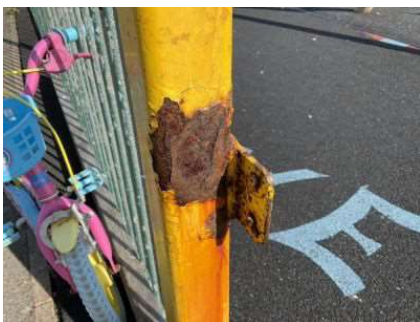
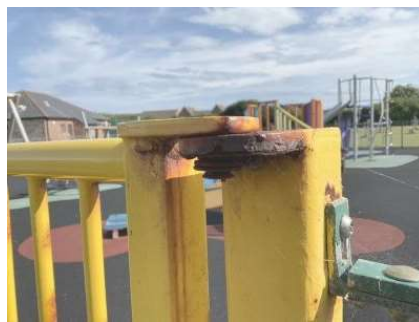
Paintwork is in poor condition.

Corrosion is present. Repair.

De-scale back to good base material and coat with lead free paint, using appropriate precautions. Repairs may be necessary where corrosion is severe.

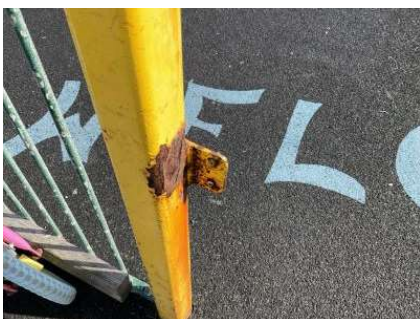
Gate buffer(s) required.

Fit a buffer.

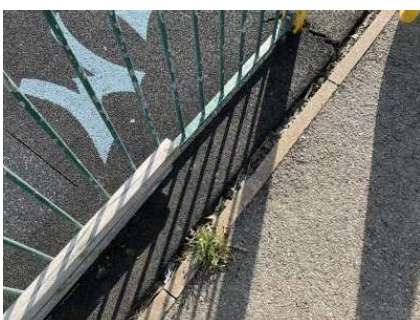
Shrinkage / separation of the surface. This may give a trip hazard.

Perimeter.

Re-glue and fill gaps and joints as necessary.

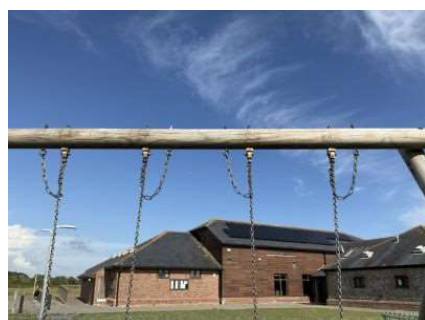
Bolt(s) loose.

Hangers loose to crossbeam.

Tighten.

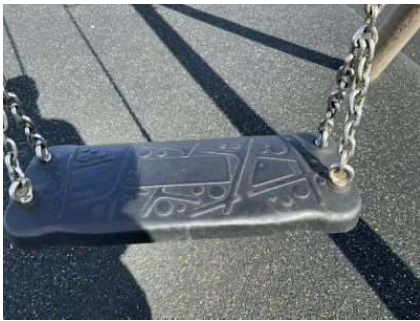
Loose swing seat eye-bolts.

Tighten connecting nuts.

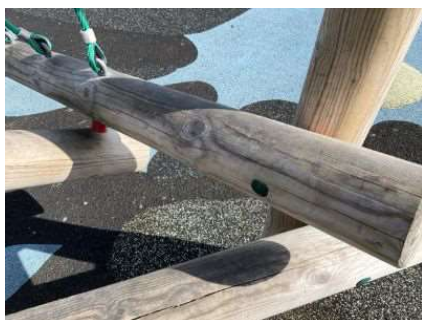
There are natural splits / shakes in the timbers.

DO NOT fill shakes. Monitor and sand back any splintered edges as required., DO NOT fill shakes. There are shakes running through fixing points. Ensure the fixings are fully secure on regular basis.

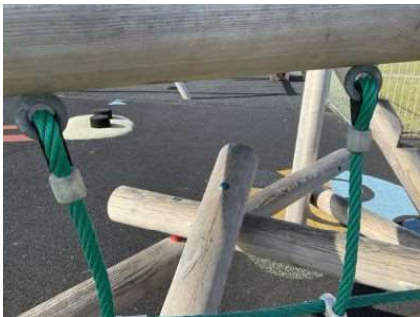
Bolt(s) loose.

Eye bolts are loosening. Tighten.

Tighten.

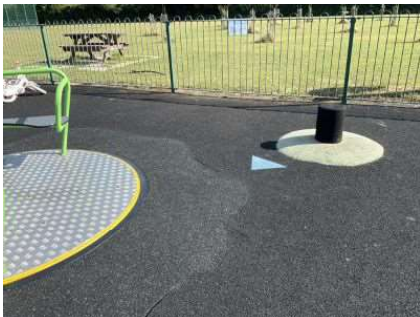
There is an obstacle in the falling space or minimum space.

A 2 m minimum space is required around this asset.

No reasonably practicable action is identified.

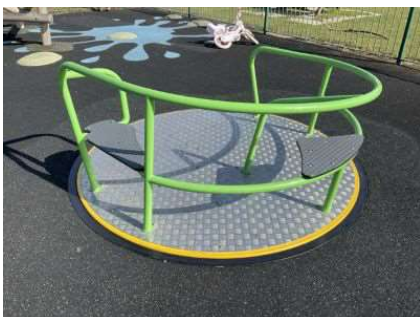
Bearings require service.

Unit is knocking when in use. Repair.

Service the bearings.

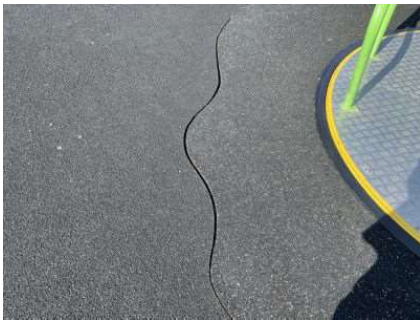
Shrinkage / separation of the surface. This may give a trip hazard.

Re-glue and fill gaps and joints as necessary.

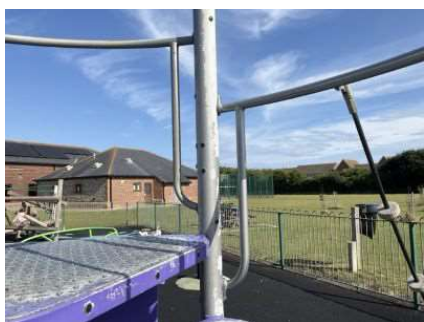
Guard rail height is below the minimum permitted of not less than 600 mm above the surface of the platform, step or ramp.

Guard rail is 500 mm above middle platform. Monitor.

No reasonably practicable action is identified.

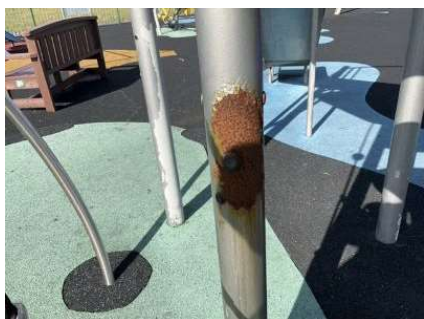
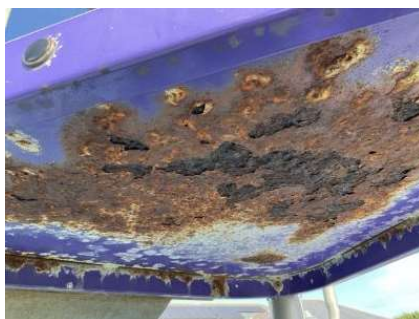
Item is rusting in places.

Repair.

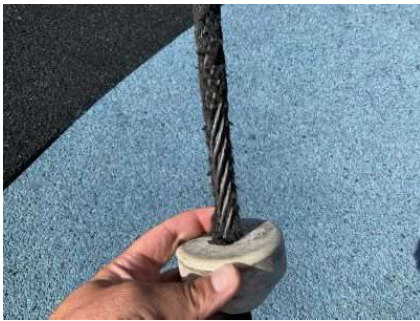
Exposed metal rope core(s).

Replace the worn ropes.

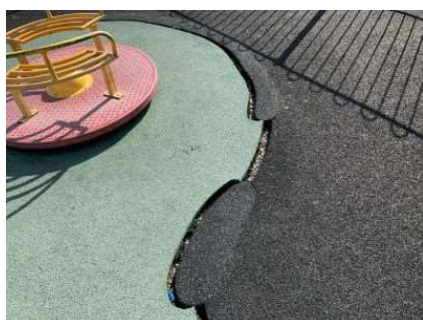
Shrinkage / separation of the surface. This may give a trip hazard.

Edge needs to be repaired.

Re-glue and fill gaps and joints as necessary.

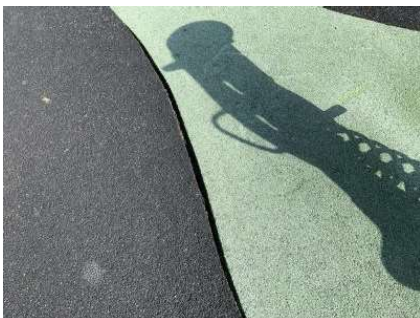
Shrinkage / separation of the surface. This may give a trip hazard.

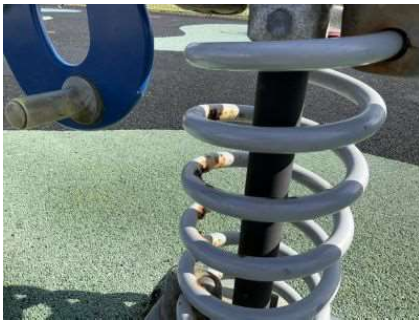
The spring is rusty. These have been known to fail without warning, leading to a collapse of the unit.

De-scale back to good base material and coat with lead free paint, using appropriate precautions. Repairs may be necessary where corrosion is severe.

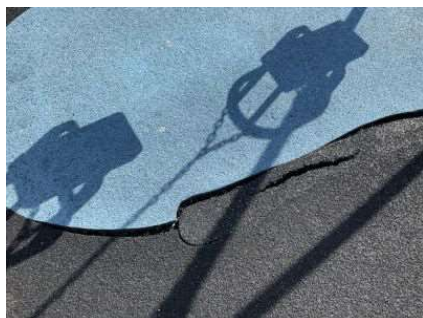
Shrinkage / separation of the surface. This may give a trip hazard.

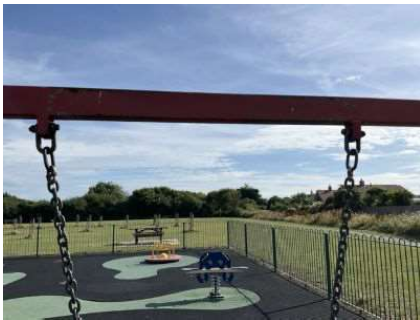
There is wear in the bushes.

Some minor wear. Monitor.

Remove shackle bolt and check bush and shackle pin wear, replacing as necessary.

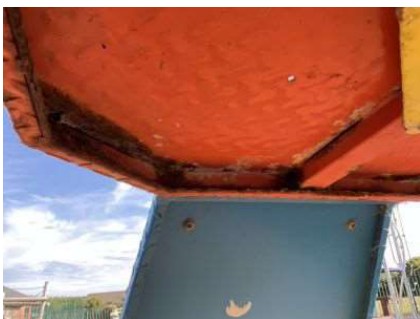
Item is rusting in places.

Repair.
