Safety Inspection Report

Annual Inspection

Bracklesham Park Playground

21 July 2025

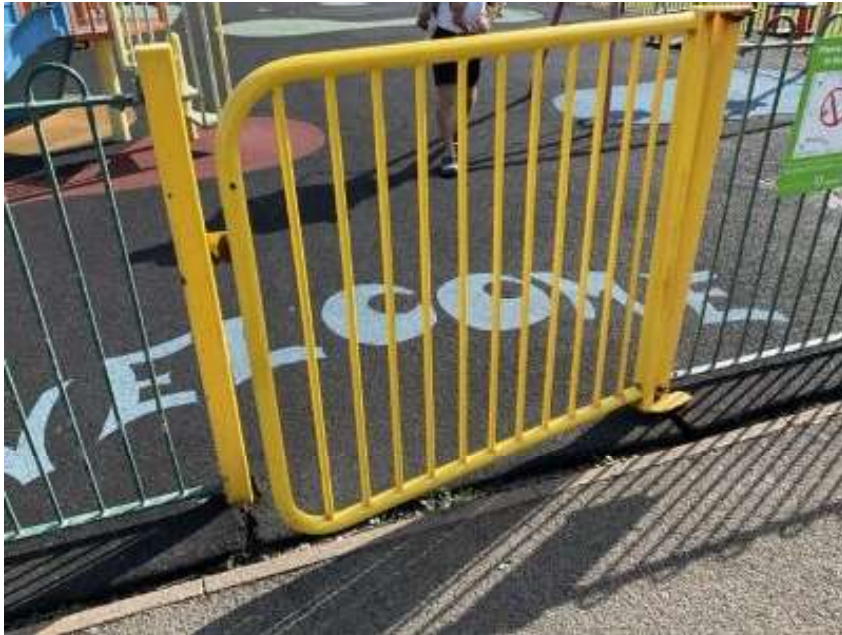
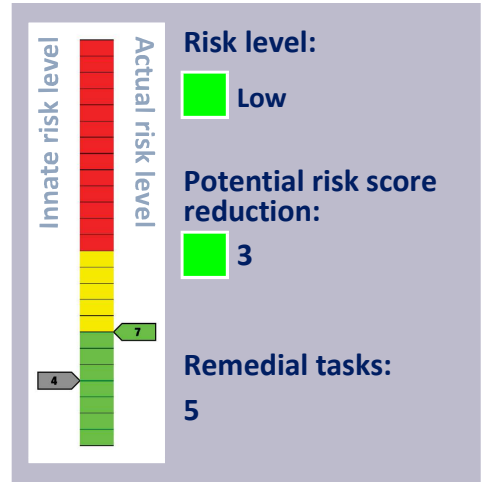
Gates

Paintwork is in poor condition.

De-scale back to good base material and coat with lead free paint, using appropriate precautions. Repairs may be necessary where corrosion is severe.

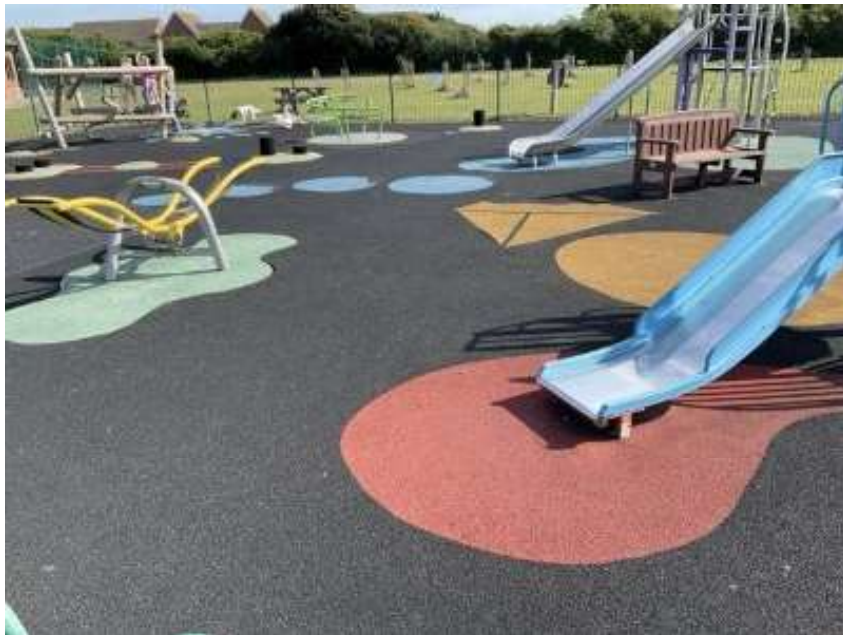
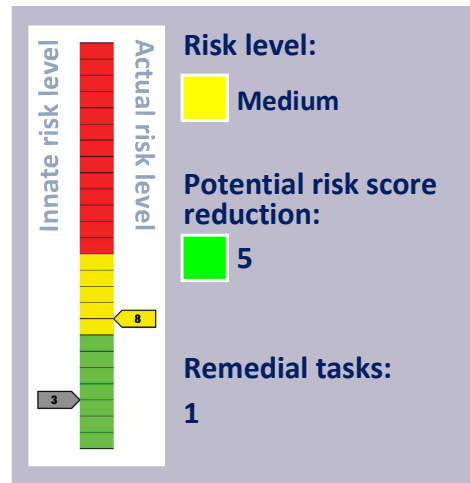
General Surface - Wet Pour

Shrinkage / separation of the surface. This may give a trip hazard.

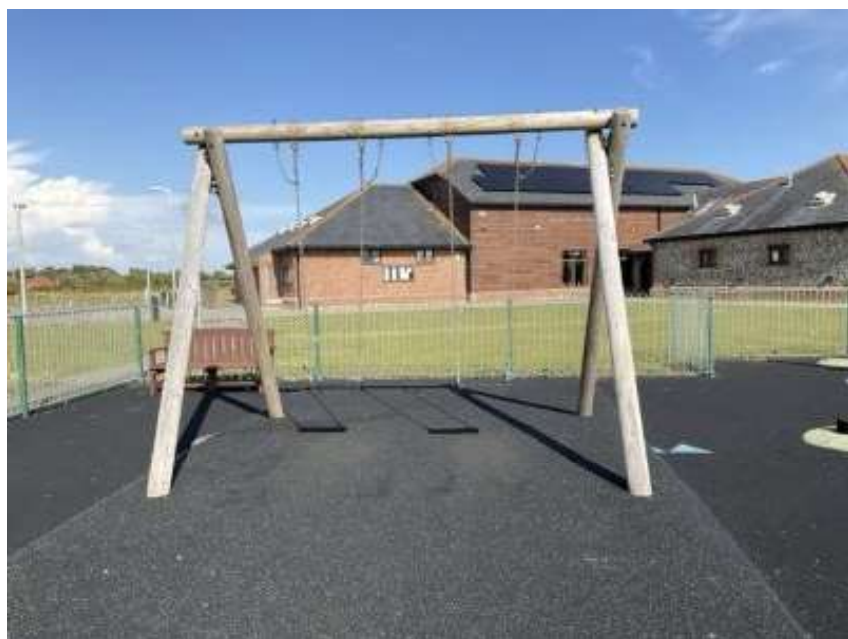
Swing - Junior - 1 Bay 2 Seat

Bolt(s) loose.

Hangers loose to crossbeam.

Loose swing seat eye-bolts.

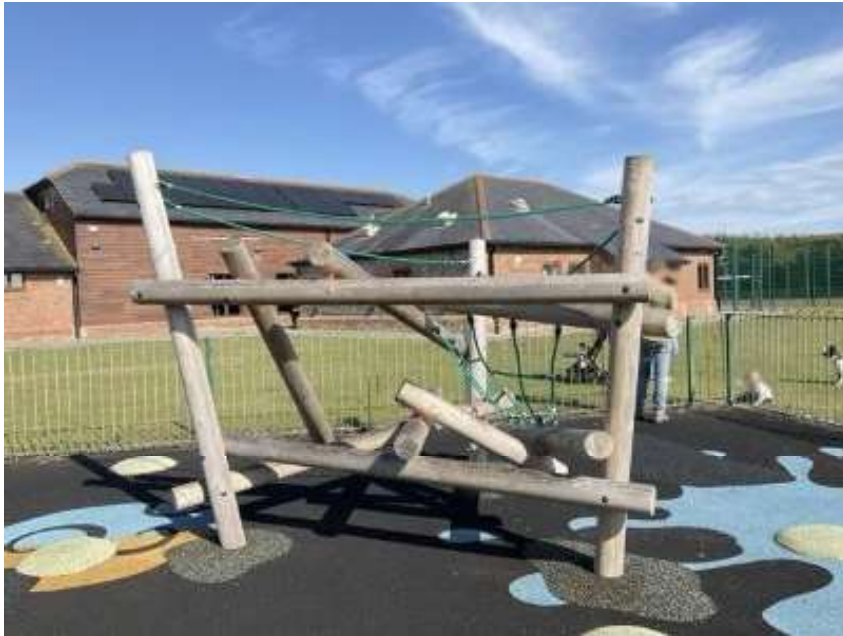
Climber - Net

Bolt(s) loose.

Eye bolts are loosening. Tighten.

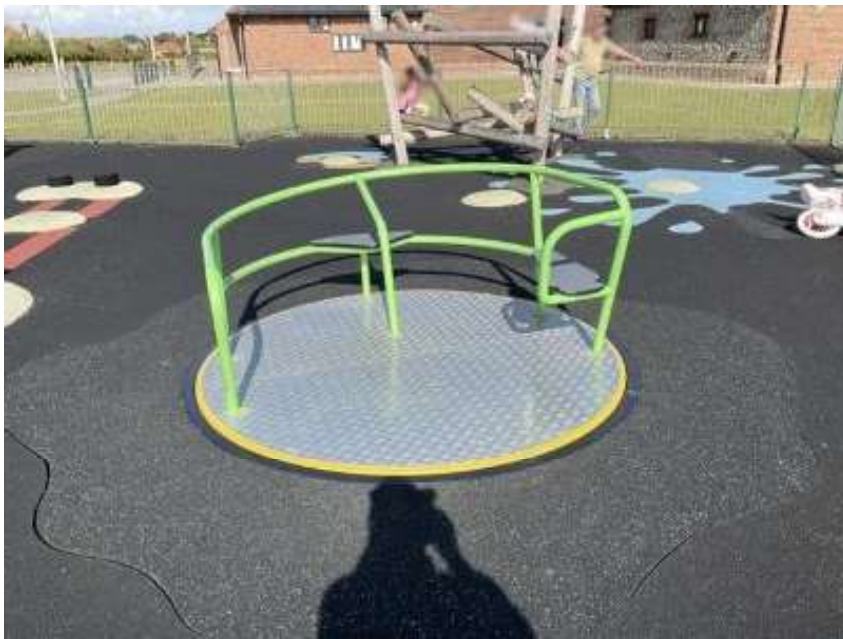
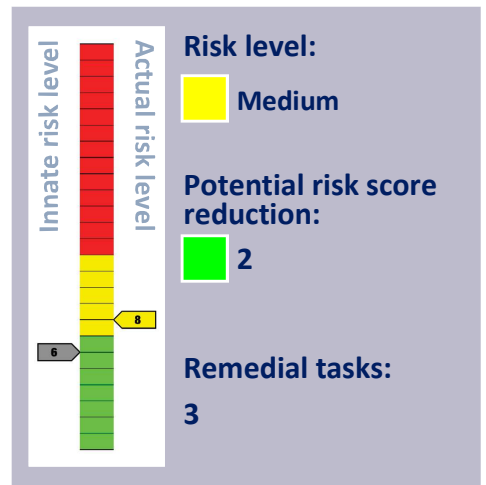
Carousel - Flush

1. Bearings require service.
2. Shrinkage / separation of the surface. This may give a trip hazard.

Unit is knocking when in use. Repair.

Shrinkage / separation of the surface. This may give a trip hazard.

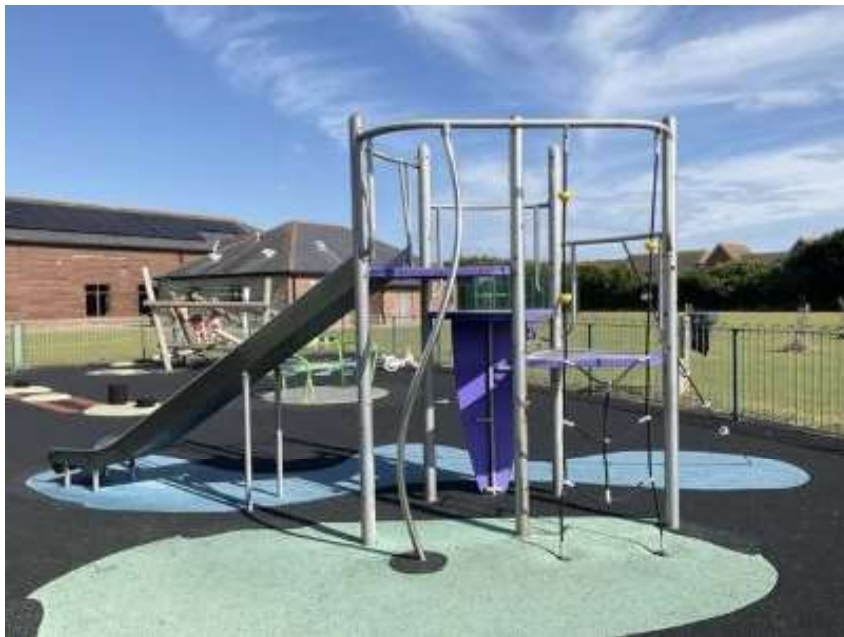
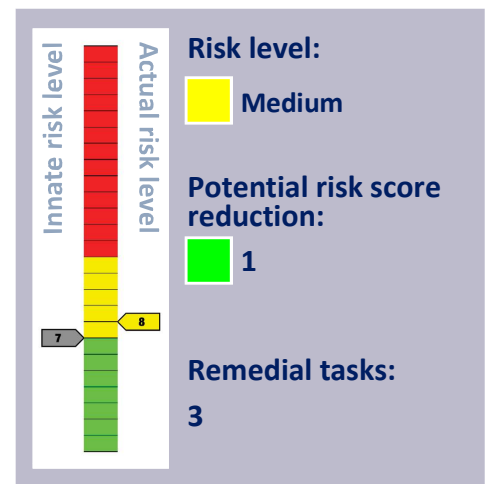
Multiplay - Climber

1. Item is rusting in places.
2. Exposed metal rope core(s).

Item is rusting in places.

Repair.

Replace the worn ropes.

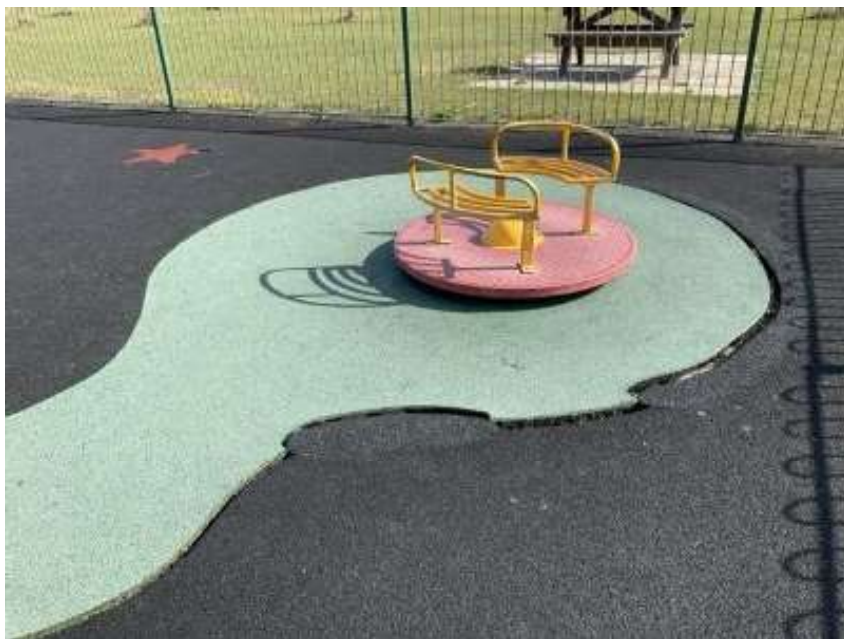
Carousel

Shrinkage / separation of the surface. This may give a trip hazard.

Edge needs to be repaired.

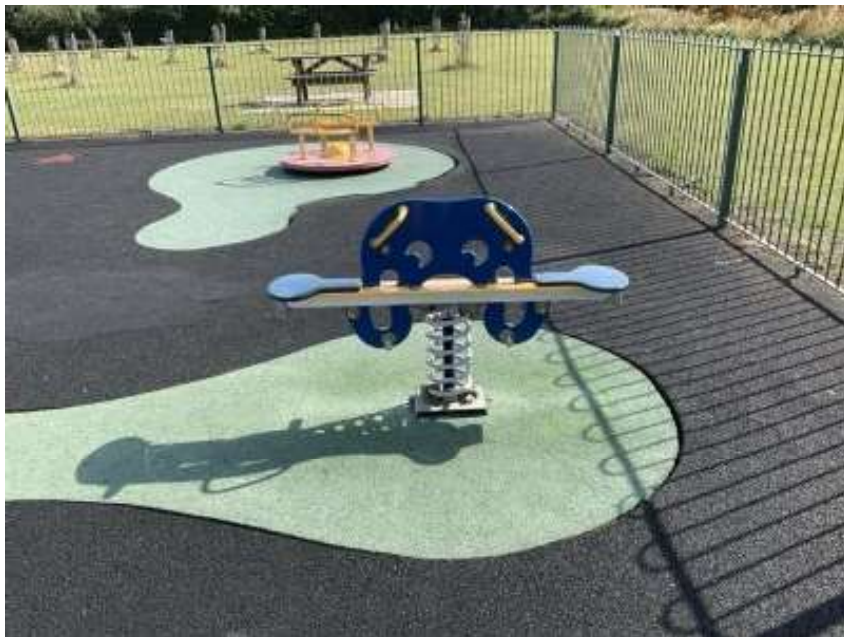
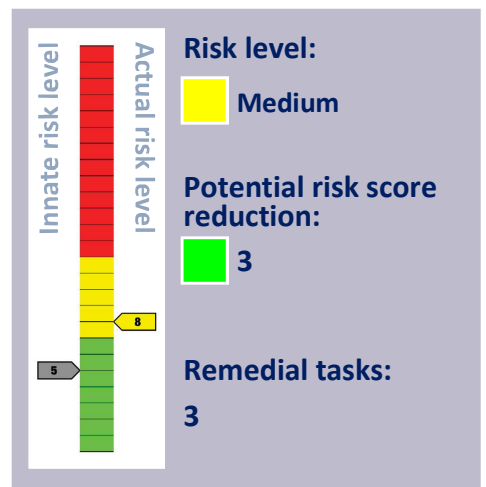
Rocker - Seesaw - Spring

1. Shrinkage / separation of the surface. This may give a trip hazard.
2. The spring is rusty. These have been known to fail without warning, leading to a collapse of the unit.

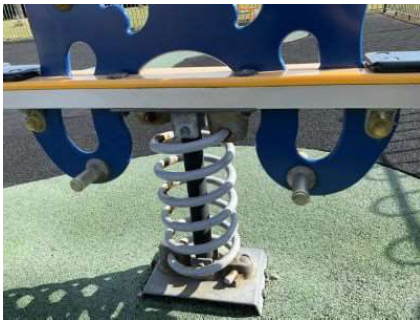
Shrinkage / separation of the surface. This may give a trip hazard.

The spring is rusty. These have been known to fail without warning, leading to a collapse of the unit.

De-scale back to good base material and coat with lead free paint, using appropriate precautions. Repairs may be necessary where corrosion is severe.

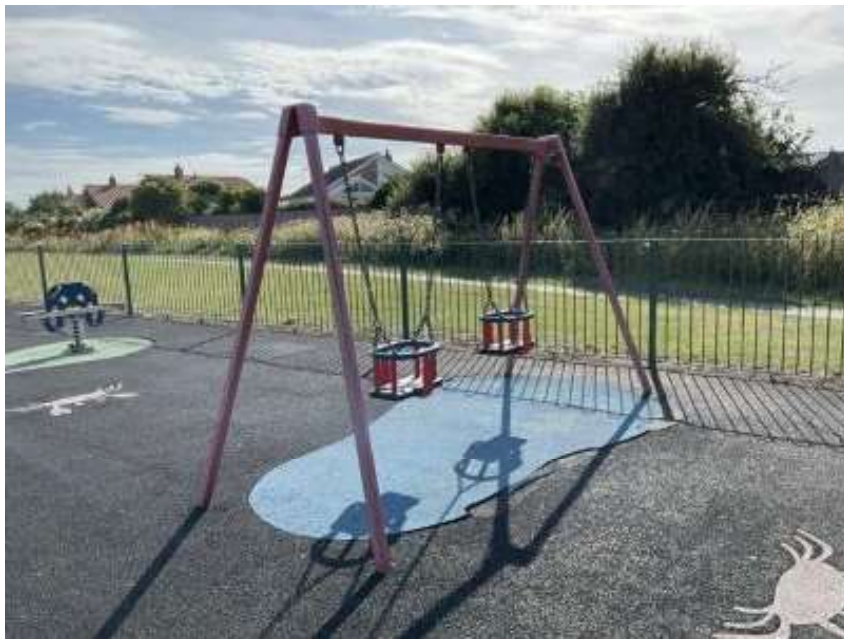
Swing - Toddler - 1 Bay 2 Seat

Shrinkage / separation of the surface. This may give a trip hazard.

There is wear in the bushes.

Some minor wear. Monitor.

Remove shackle bolt and check bush and shackle pin wear, replacing as necessary.

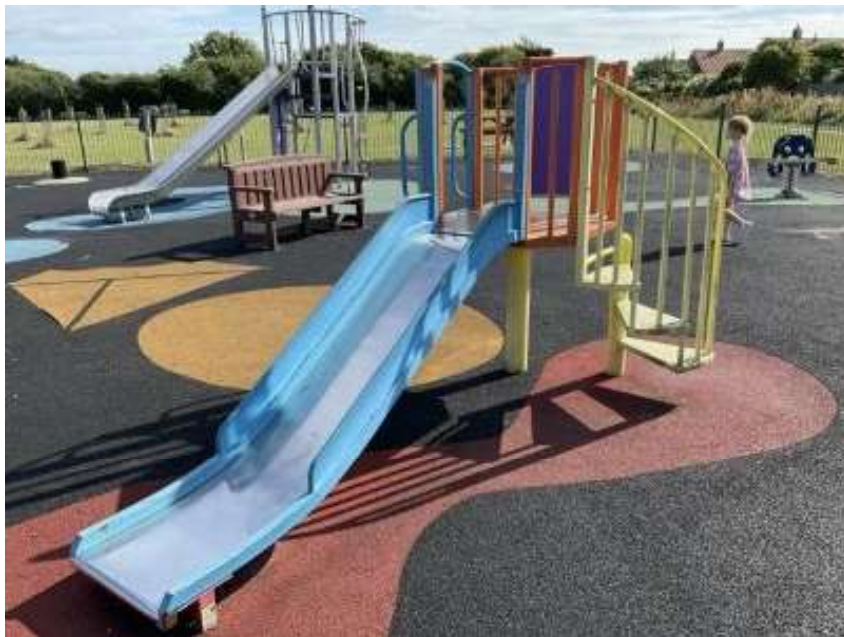
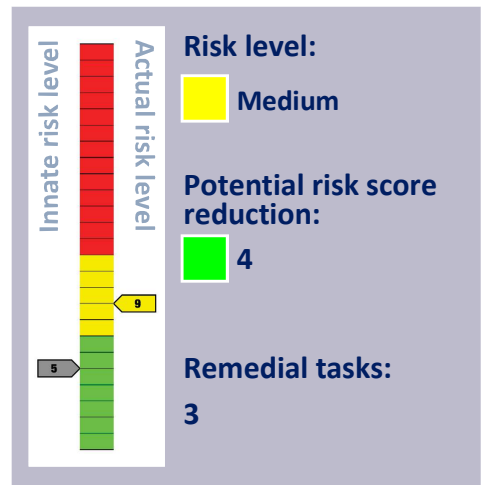
Multiplay - Toddler

The item has the following maintenance findings:
1. Item is rusting in places.
2. The wet pour surface is separating at the joints.

Top slat is warping. Repair.

Item is rusting in places.

Repair.
